Pinelands Commission Basin Failure Assessment and Investigation

Keith J. Merl, PE

Princeton Hydro, LLC, 1105 Laurel Oak Road, Voorhees, NJ

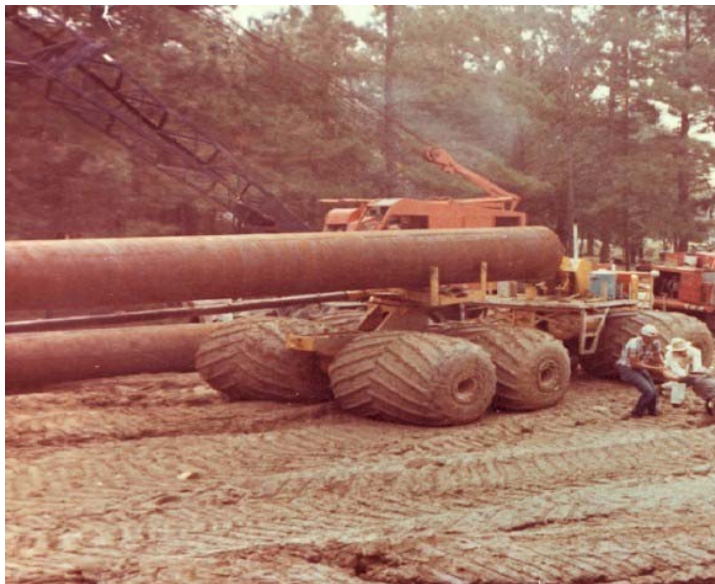
Illustration 1: Low Ground Pressure Tires depicts what a low ground pressure tire looks like. Compared to the

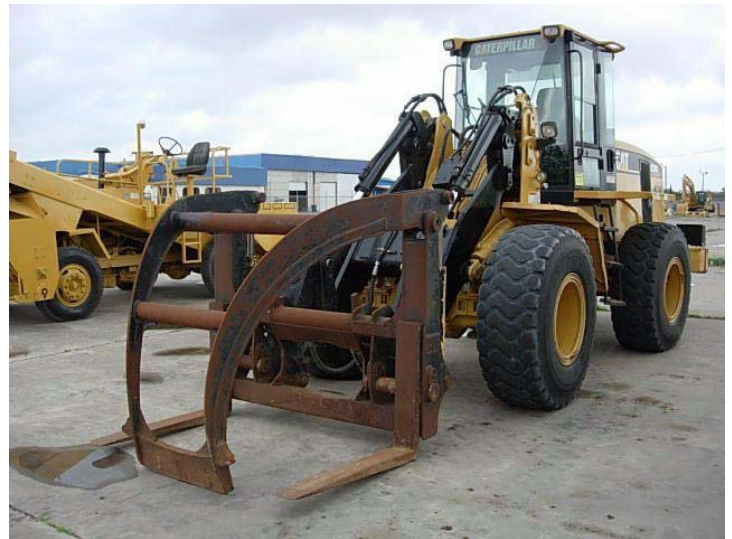
Illustration 2: Standard Rubber Tire Loader
placement) up to 4 psi might be allowable.

Referencing Illustration 2: Standard Rubber Tire Loader, this particular Caterpillar is considered a “small” unit, weighing in at the lightest weight of $\pm 28,000$ lbs. This load is distributed over four tires with ± 29.5 ” wide tread and a contact length of $\frac{1}{2}$ the width (15”); provides for a contact pressure of 12.5 psi. This would be 3 to 6 times greater than considered low ground pressure.

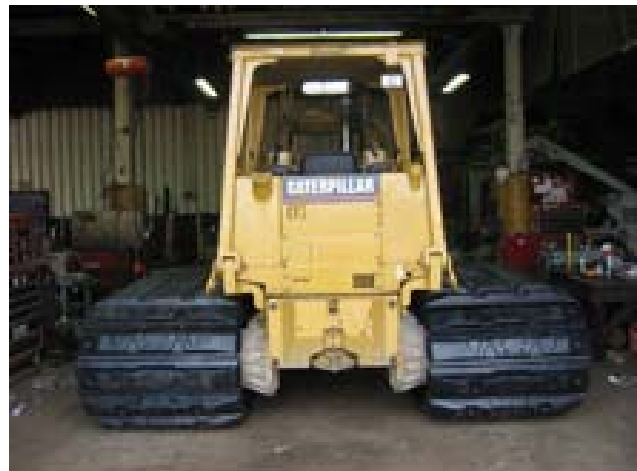
Other ways to achieve low contact ground pressure is through the use of wide tracks. Low ground pressure tracks are typically made from plastic, not metal. Illustration 4: Low Ground Pressure Tracks depicts what a standard piece of construction equipment looks like with low ground pressure tracks attached to it. A similar piece of equipment is provided in Illustration 3: Standard Track Mounted Equipment that is commonly used on site. Specifications provided by CAT Equipment reveals that even this small track mounted dozer provides more than 5 psi.

This could be considered double what a suitable ground contact pressure (to prevent infiltration clogging) should be for the bottom of these basins.
