Villanova Seepage Pits

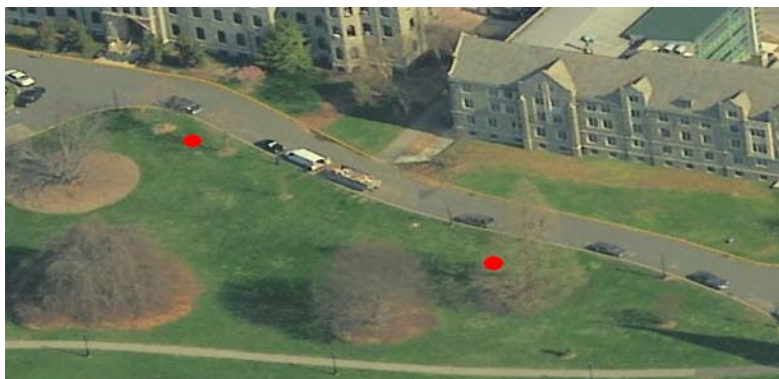
Several seepage pits located on the southern side of Tolentine Hall, located at Villanova University in Villanova, Pennsylvania were discovered in July 2005. These seepage pits presented a unique opportunity to study the long-term impacts of infiltration. The history of these pits is still somewhat uncertain because of their age and a fire in Tolentine Hall in 1923. It is understood that the structures were built at the turn of the 20th century around the time Tolentine Hall, at the time called College Hall, was built. Originally, four pits existed in the area to collect and infiltrate stormwater off of Tolentine Hall, St. Thomas Monastery, and St. Thomas of Villanova Church which are located on the southwestern corner of the main campus.

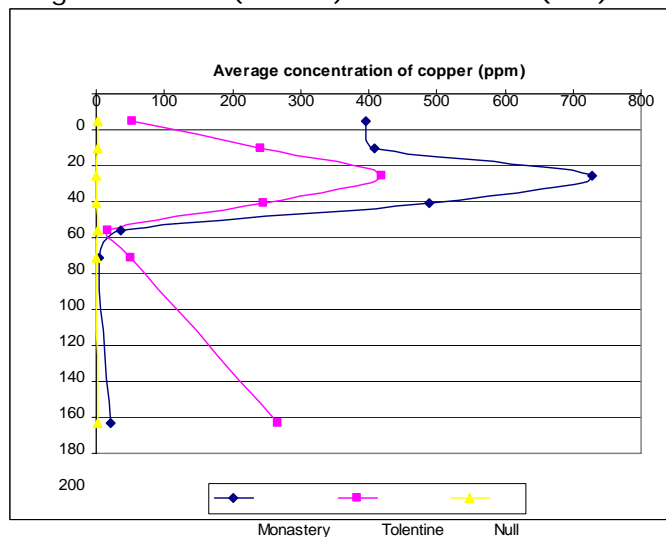
Currently, the Tolentine pit is not in use. The total impervious area contributing to the Monastery seepage pit is 2617 m² (28170 ft²). Tolentine Hall has a roof size of 900 m² (9670 ft²) and St. Thomas Monastery has a roof size of 1720 m² (18500 ft²). The Monastery pit has a height of 4.1 m (13.5 ft) with a 1.8 m (6 ft) diameter resulting in a total volume of 10.8 m³

(381.5 ft³), which is to 10,800 L (2850 gallons).

Our analysis showed that although elevated copper concentrations were found in the soils beneath the pits, these levels were not above Pennsylvania standards for clean fill. The infiltration capacity of the Tolentine pit was quite high; however, the infiltration capacity of the Monastery pit had been compromised by the inadvertent addition of organic matter. A restoration design using earthquake drains was used to alleviate the Monastery pit infiltration capacity problems. Our study into the efficacy of this improvement technique was inconclusive.
