Pinelands Commission Basin Failure Assessment and Investigation

Keith J. Merl, PE

Princeton Hydro, LLC, 1105 Laurel Oak Road, Voorhees, NJ

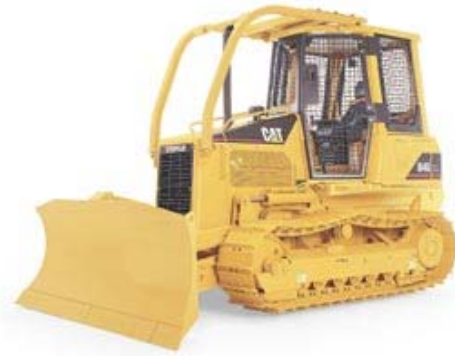
This could be considered double what a suitable ground contact pressure (to prevent infiltration clogging) should be for the bottom of these basins.

Illustration 3: Standard Track Mounted Equipment
